Manhole Inspection Summary

Manhole # S17EE1064MH

Record Plat: **17EE1** Node: **064** Status: **New Manhole (Not in GIS)** Insp Date: **3/22/07 12:00 AM**

Location Address: **3801 GREENSPRING AVE** Cross Street: **KEYWORTH AVE**

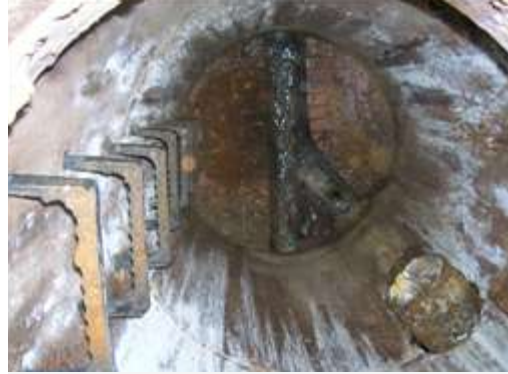
Top View

Bench and Channel debris.

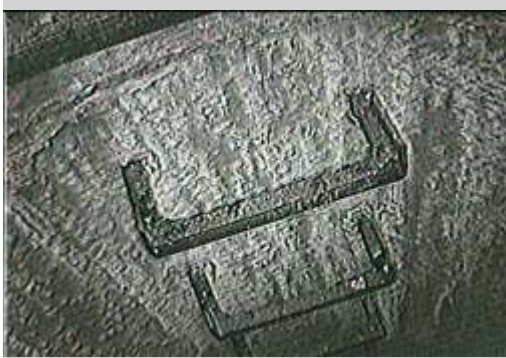
Defect

Barrel infiltration.

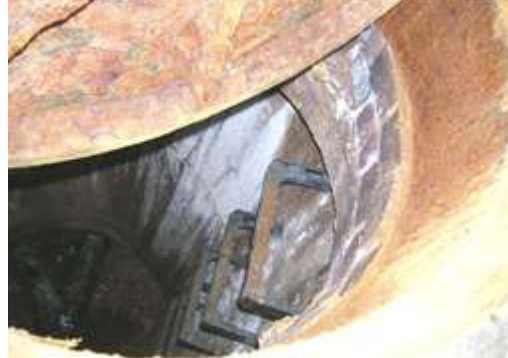
Defect

Frame leak. Adjustment, Corbel and Barrel infiltration - other side.

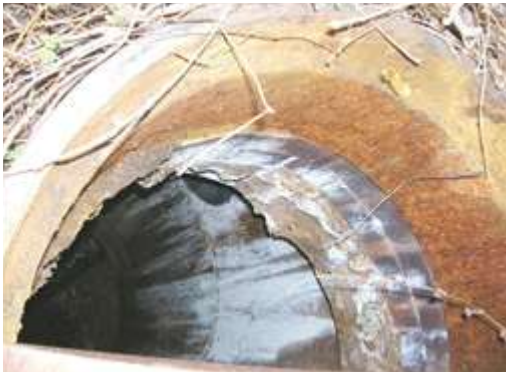
Defect

Frame leak. Adjustment, Corbel and Barrel infiltration - other side.

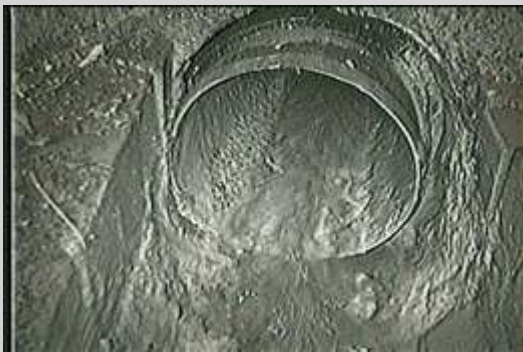
8 in. Circular Gravity Sewer Pipe Out @ 12 O'Clock

Comments **This MH has a Baltimore County lid. The O12 pipe seal is not flush to the pipe. The I6 pipe seal is not flush to the pipe. The I4 pipe seal is not flush to the pipe.**

Deposits: ☐ None ☐ Mud ☐ Sludge ☐ Debris ☒ Grease

Infiltration: **Evidence** Pipe Seal Cond: **Unknown**

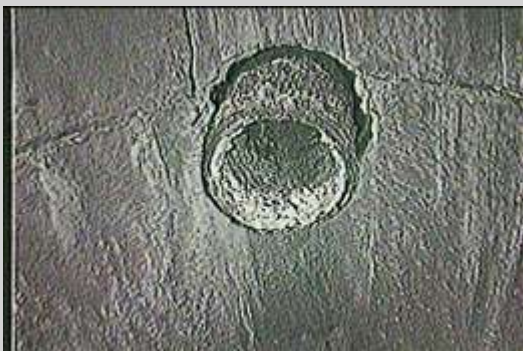
8 in. Circular Gravity Sewer Pipe In @ 4 O'Clock

Deposits: ☐ None ☐ Mud ☐ Sludge ☒ Debris ☒ Grease

Infiltration: **Evidence** Pipe Seal Cond: **Unknown**

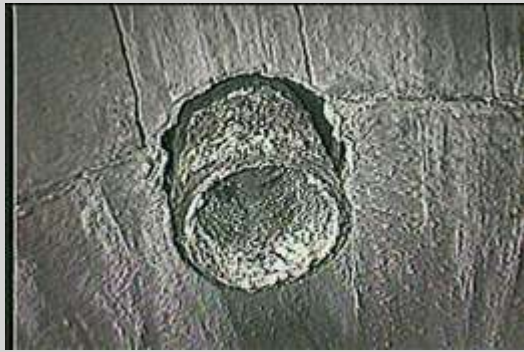
Pipe In @ 6 O'Clock

Infiltration: **Evidence** Pipe Seal Cond: **Unknown**
